Analyzing Accidents in Civil Construction for Safety Work at Height

3.1 Case Study

Held in a confectionery, Bolo e Cia, located at Avenida Camapuã, 2332, east of Manaus-AM. The work performed is privately linked, being only the agreement between employer and employee, a service in a short period, as well as many that exist in the city.

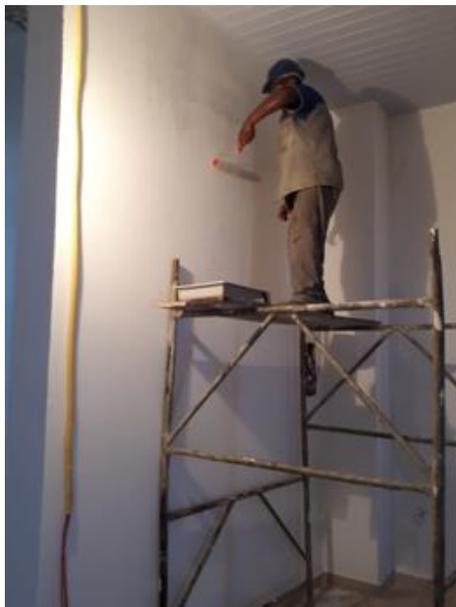
Figure 1. Irregularities

It is notorious that the lack of responsibility, the non-compliance with the laws and the self-confidence acquired over the years, even after accidents occurred, continued to commit the same recklessness as observed in Figure 1, one can notice the lack of signs in which the Standard Regulatory 26 [11], in item 26.1.1, establishes the use of colors for safety in establishments or workplaces, in order to alert the existing risks to the people who travel nearby and the employee himself, even in the use of this device that not being used, the use of this resource does not dispense with the use of other preventive means in accordance with NR 26 [11], item 26.1.3. The need to isolate and signal the site is to try to minimize risks and accidents. Scaffolding shall consist of shims, fixed base, diagonal, ladder, safety ring, railing, floor, baseboard and screen. According to norm NR-18 [12], item 18.15.6 states that scaffolding should have a railing and skirting system, including headboards, all around the perimeter, reducing the risk of falling objects and the employee himself, obeying the protective measures are the height of 120 cm for the upper crossbar and 70 cm for the intermediate, a footer with a height of 20 cm, in addition to the screen fills ensuring the safe closing of the gaps (item 18.13.5). In item 18.15.7 it is forbidden to remove any safety device from scaffolding or to nullify its purpose.

The scaffolding used by the employee is the simply supported fixed scaffolding without baseplate, used outdoors, which is where the structure remains rigid preventing its displacement, for each type of scaffolding can be modified as for facade, is the scaffolding fachadeiro therefore allows the access of people and materials to the work. The used note the lack of a baseboard and the lack of regularity of the floor, making it even more necessary to use shims to increase strength and ensure more stability, which according to NR 18 [12], in Item 18.15.10 which states that the scaffolding risers must be supported by solid and level base shoes capable of withstanding the stresses and loads transmitted.

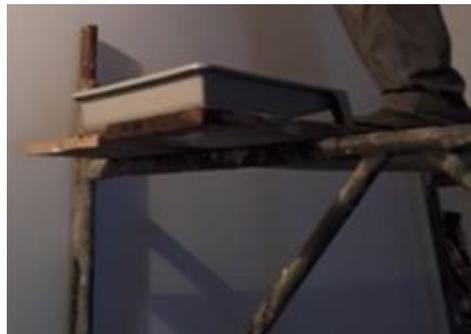
Figure 2. Scaffolding floor

According to NR-18 [12], Item 18.15.3 The working floor of scaffolding shall be completely lined, non-slip, level and securely fixed and locked, and the floor may be all metal or mixed with metal structure. and synthetic material or wood or all wood, item 18.15.3.1, the sizing should be done by a qualified professional, according to item 18.15.3.2. The use of wood shavings in scaffolding is also prohibited, item 18.15.5.1, that is, it is not possible to use leftovers of wood that are in bad condition, with cracks and wet, compromising its resistance and cannot be painted. in order to hide the deformities, item 18.15.5, the user being totally irregular according to the safety standard as shown in figure 2.

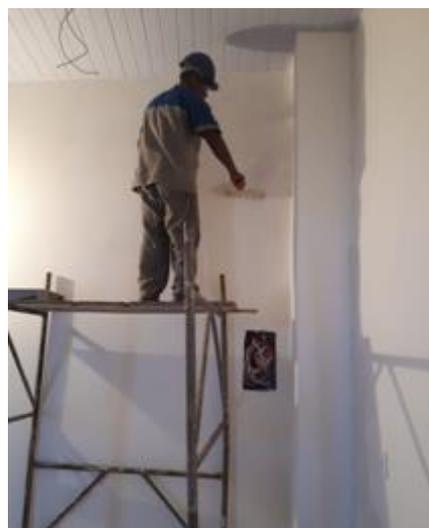
Figure 3. Worker near electricity

In addition to all the mentioned items there is still the risk of scaffolding close to the wiring of electric wires as seen in figure 3, the NR-18 standard [12], in item 18.15.4 informs that precautions should be inserted in PCMAT. Taken when assembling, disassembling, and moving scaffolding near power grids, due to the risk of shock, parts of a scaffolding frame carry electricity and may be hazardous if exposed to power cords or conductors.

Electric shock: keep distances from mains because the scaffolding are conductors of mains; use of inappropriate equipment.

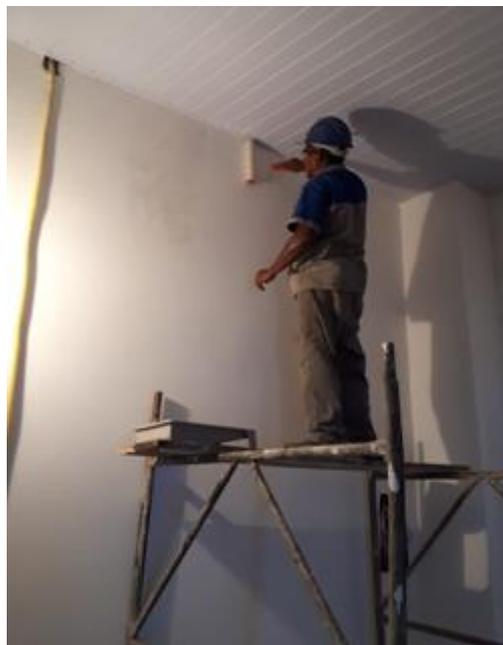
Figure 4. Worker at eminent risk

The work had several nonconformities such as lack of PPE, irregular scaffolding, no supervision, no training or guidance from employer to employee, or any risk assessment that might have been made, contrary to NR- 6 [13], Item 6.6.1, related to work safety at height, characterizing a serious and imminent risk, which may cause accidents and even lead to death of the worker.

The image shows that the employee does not have the proper PPE, because the user was at a height of approximately 2.5 meters and were totally of the standard that the NR-35 standard [5] determines to have the minimum safety, in which If activities above 2 meters are already considered work at height, it is of fundamental importance to strictly follow the established law, because most of the accidents registered are work at height. As shown in figure 4, when wearing a helmet, he does not use it with a jugular, risking that he detaches if his head, also has no seat belt, protective glove, lanyards or parachute, going against all safety laws.

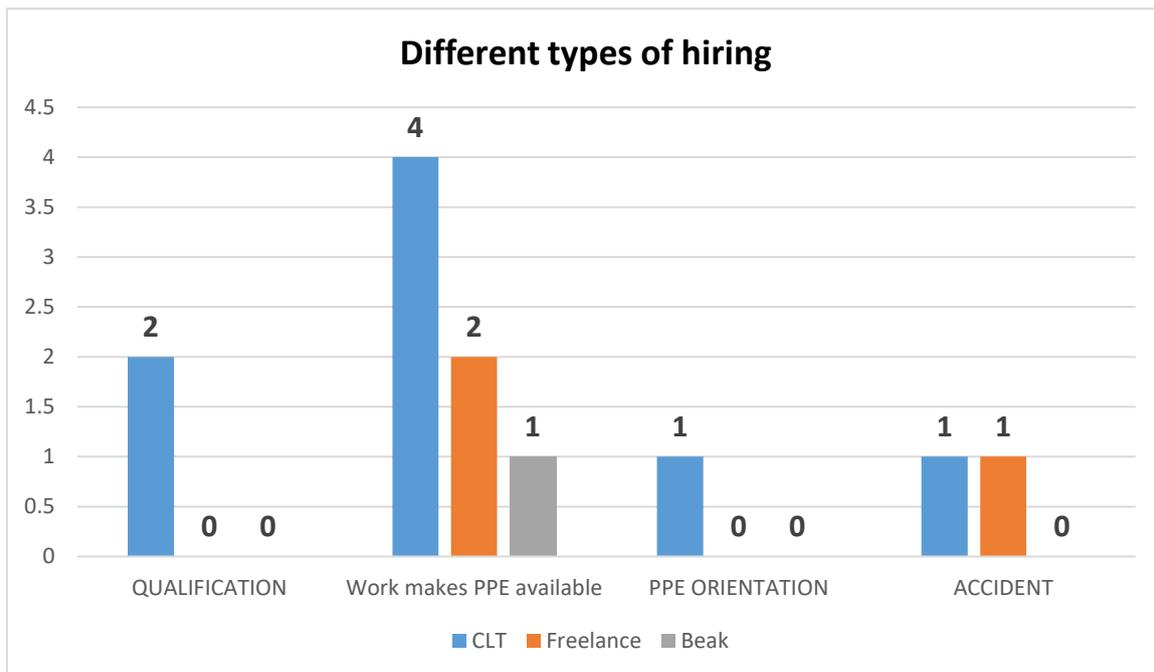
Graph 1. Comparison

The comparison was shown in graph 1 below, made only with 3 employees who work in this area.

It can be observed that in the three cases only the contractor with a formal contract has qualification, which according to norm is necessary to avoid the risk of falling by owning knowledge. The equipment available is the minimum, being only gloves only, and the employer should provide the equipment should provide guidance on how to use it. In the above cases only the signed card has guidance, leaving the other two respondents without, because such laws and regulations are not disclosed, nor is there a strict supervision on renovations or even construction, leaving many at the mercy of luck and taking risks. serious. In the following pie chart 2, you compare the PPE.

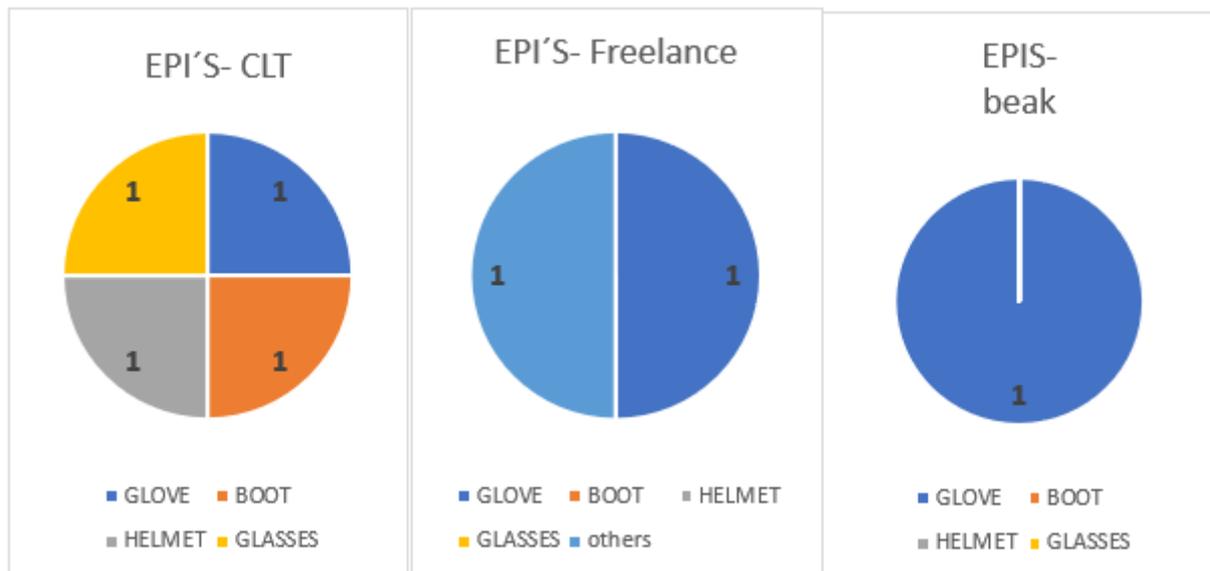
Graph 2. Comparison of employer-provided PPE

The lack of commitment between the parties diminishes the responsibility of both employer and employee, leaving both and especially the employee at risk. The use of this equipment is not for decoration, but for life protection, but should be used correctly, its misuse or misuse, makes the epi useless according to what the manufacturer informs.
